09/977026
1/9
20 FIGS

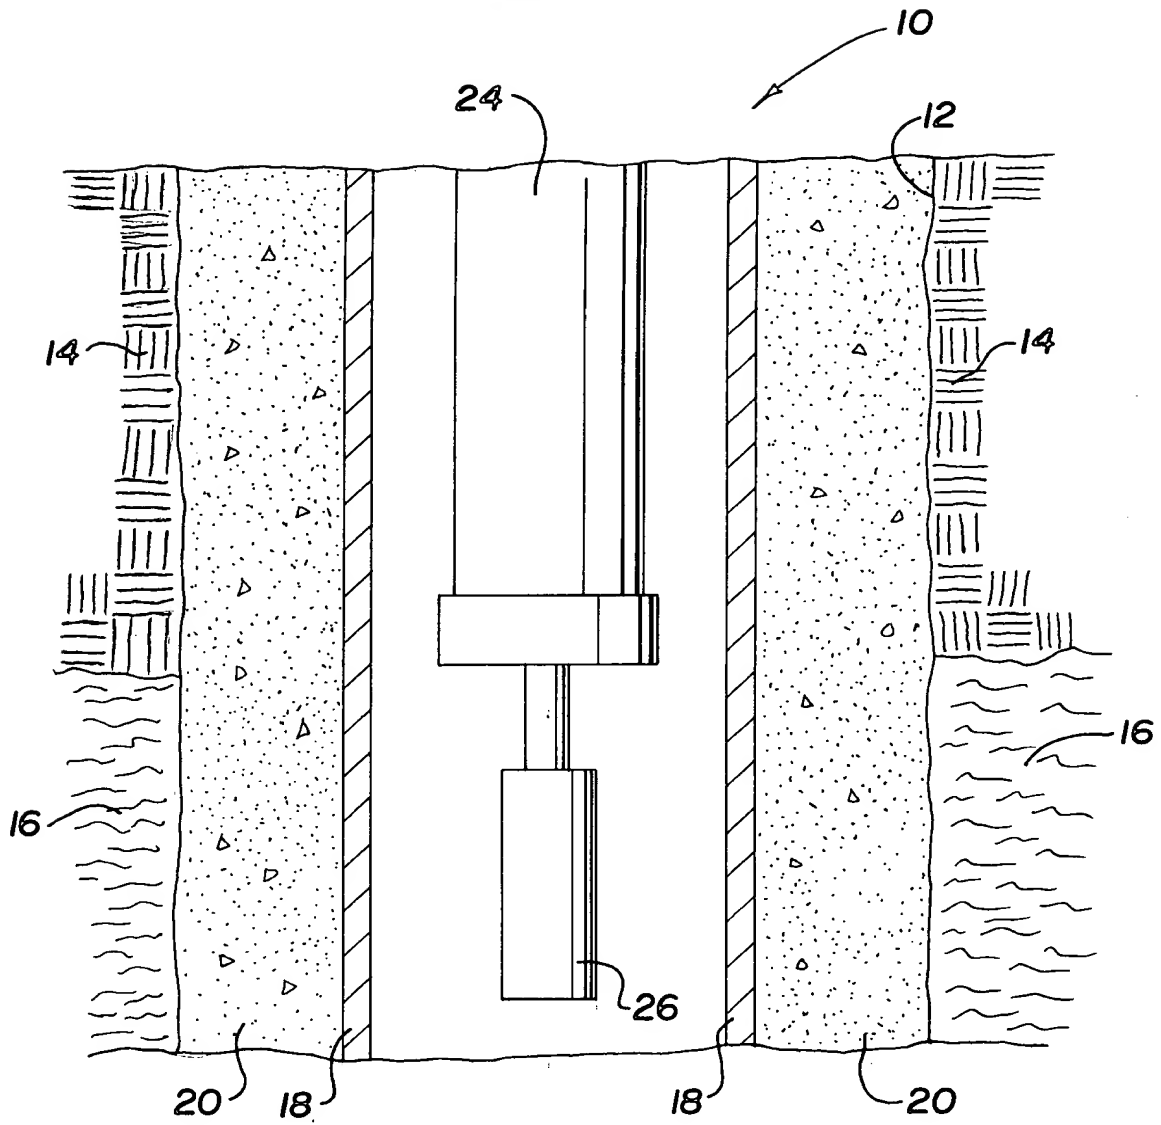
Fig. 1

FIG. 1 is a cross-sectional view of a wellbore 18. The wellbore 18 is lined with a casing 200. The casing 200 is composed of sections 202 and 206. The sections 202 are connected by joints 218. The joints 218 are sealed with seals 214. The casing 200 is surrounded by a cement sheath 228. The wellbore 18 is filled with a fluid 20.
